Understanding the Hazard

Exterior Wall Assemblies

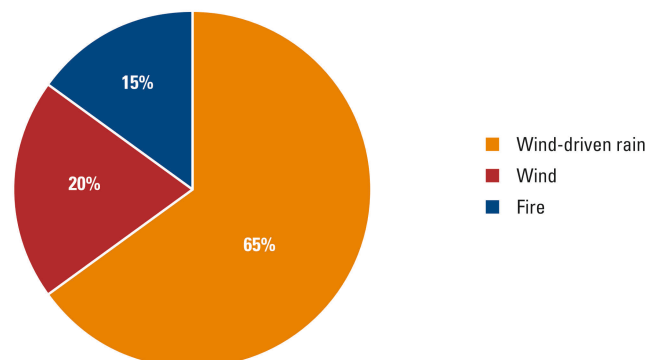
Losses by Cause (percentage of cost)

A study of FM Global client losses involving EIFS construction over a recent 10-year period shows the most significant causes (based on cost) were wind-driven rain, wind damage and fire.

Source: FM Global clients

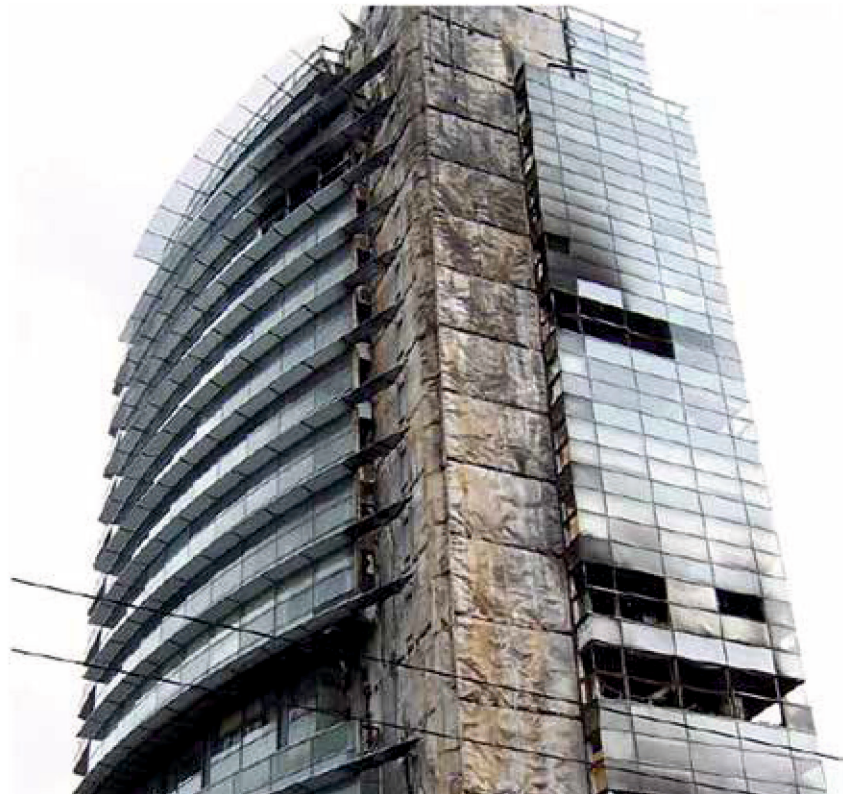
Combustible wall construction allowed fire to spread up the corner of this building.
