UNDERSTANDING THE HAZARD

Fire Following Earthquake

EQUIPMENT

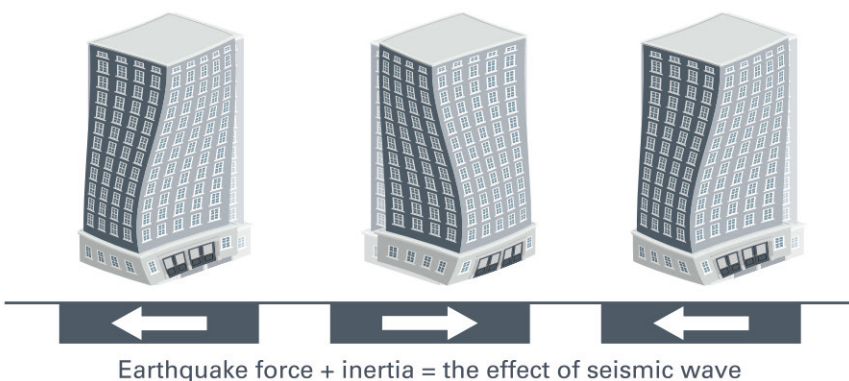
EXAMPLE OF DIFFERENTIAL MOVEMENT (IN ONE DIMENSION)

As a seismic wave passes beneath a building, it oscillates in three dimensions, imparting horizontal motion in both a push-pull and a side-to-side cycle, and vertical or up-and-down motion (see illustration on page 3). As the wave passes, it first moves the ground and base of the building, while all other parts of the building above ground level remain stationary. Within seconds, the upper levels also begin moving in the direction of the initial motion. The base will have reversed direction, however, because of the wave's motion (push-pull); as a result, the base and upper levels oscillate, often moving in opposite directions.

As the cycle continues, the entire structure moves and sways. Earthquake ground motions typically are amplified by the building — horizontal design forces at the roof can be two- to four-times larger than those at ground level. Earthquake forces on objects in a building also are affected by the items' physical properties (e.g., mass and stiffness). For example, heavier items will experience larger forces. Moreover, an earthquake can cause inadequately anchored equipment to slide, overturn or swing, regardless of size or weight. Piping or electrical connections to this equipment can be severed unless adequate flexibility has been provided. Fittings and couplings on unbraced piping can separate or leak due to excessive bending, rotation or movement. Excessive swaying of the pipe can damage hangers, resulting in loss of vertical support for the pipe, and often leading to catastrophic failure.

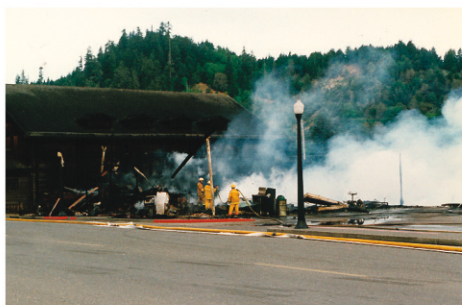
This post-earthquake fire grew uncontrolled when damage to underground piping impaired the sprinkler system and delayed water delivery. Photo courtesy of ABS Consulting — EQE Structural Engineers Division.
